An Asbestos Building Audit Survey (ABAS) was conducted in the Federal Building (NM0005ZZ) located in Carlsbad, New Mexico. The purpose of the survey is to inspect and assess this GSA operated building for the presence and condition of asbestos-containing materials (ACM) according to the General Services Administration (GSA), Environmental Protection Agency (EPA) and Occupational Safety and Health Administration (OSHA) guidance.

Under this program, the Federal Building (NM0005ZZ) located in Carlsbad, New Mexico was surveyed for the specific identification/location of all suspect asbestos-containing materials (ACMs) during July

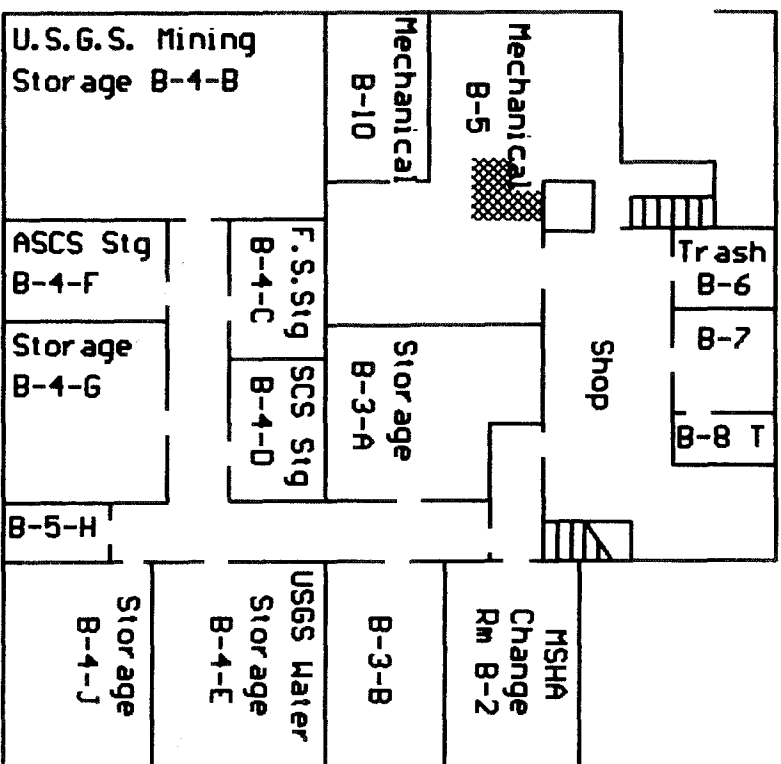
Figure 1.1  
Basement Floor

Boiler Exhaust Flue  
ACM Homogeneous Area

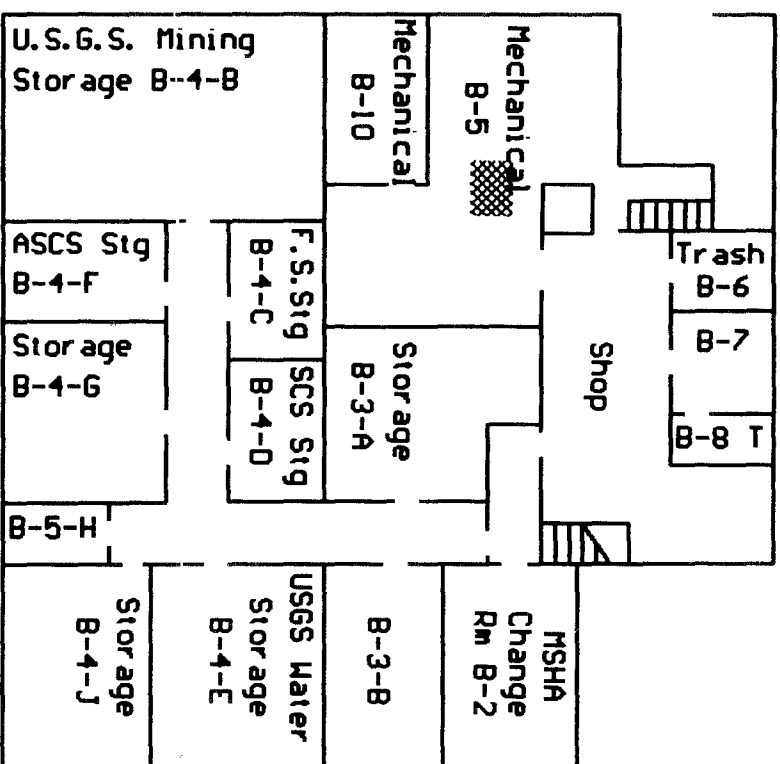
Figure 1.2  
Basement Floor

Boiler Refractory  
ACM Homogeneous Area

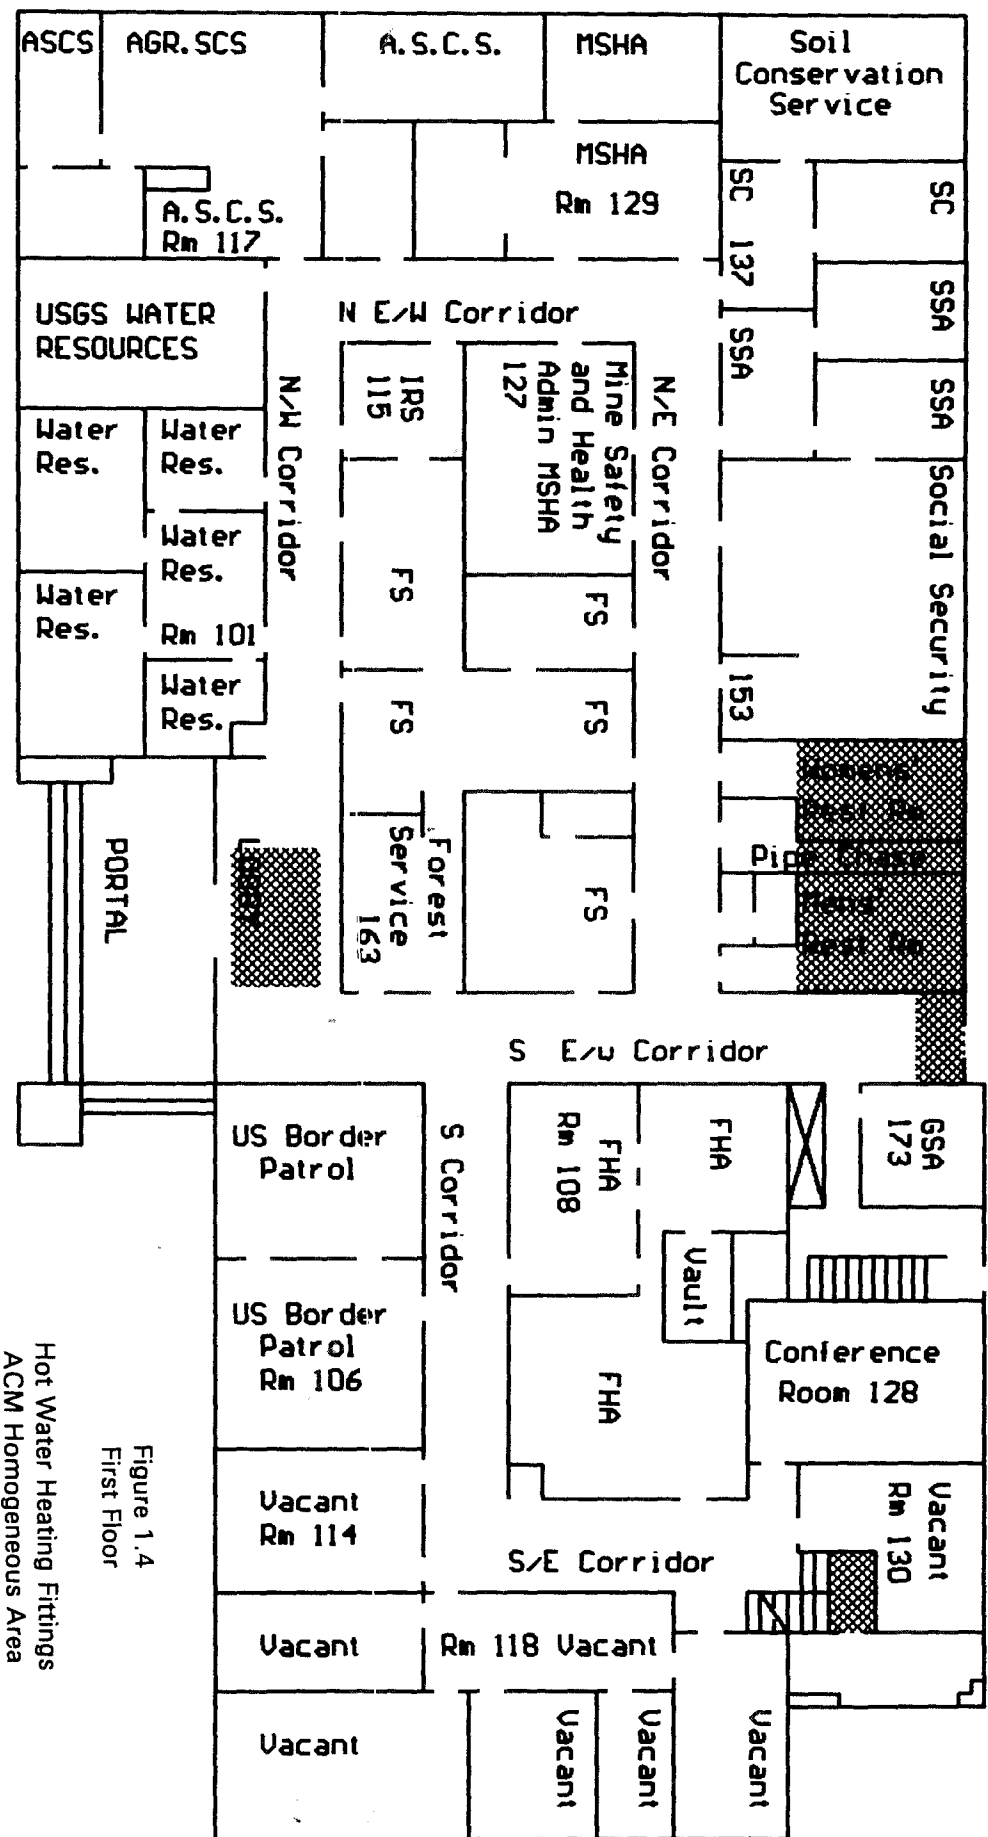
**Figure 1.4**  
**First Floor**

## Hot Water Heating Fittings ACM Homogeneous Area

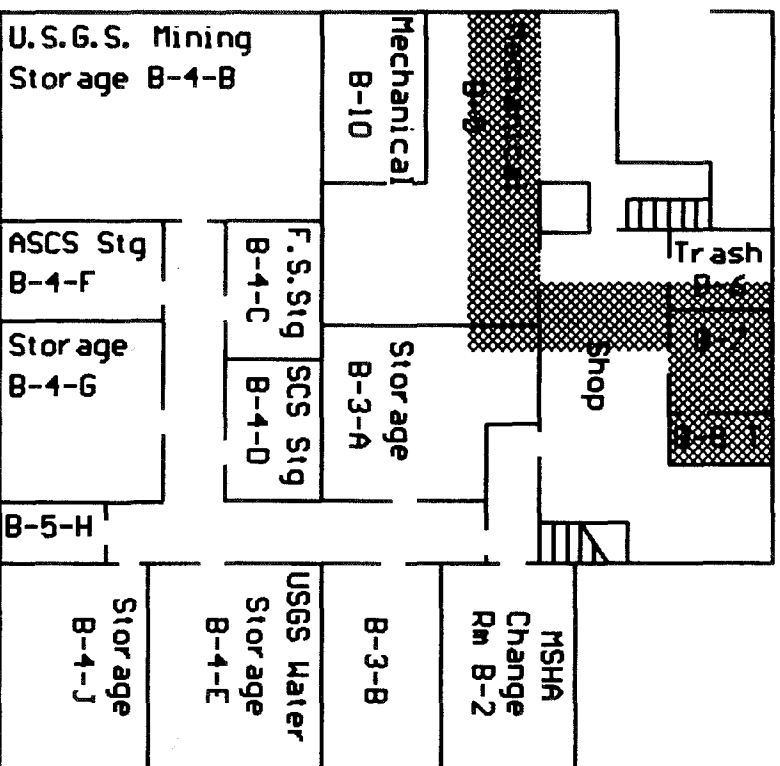
Figure 1.5  
Basement Floor

Domestic Hot Water Fittings  
ACM Homogeneous Area

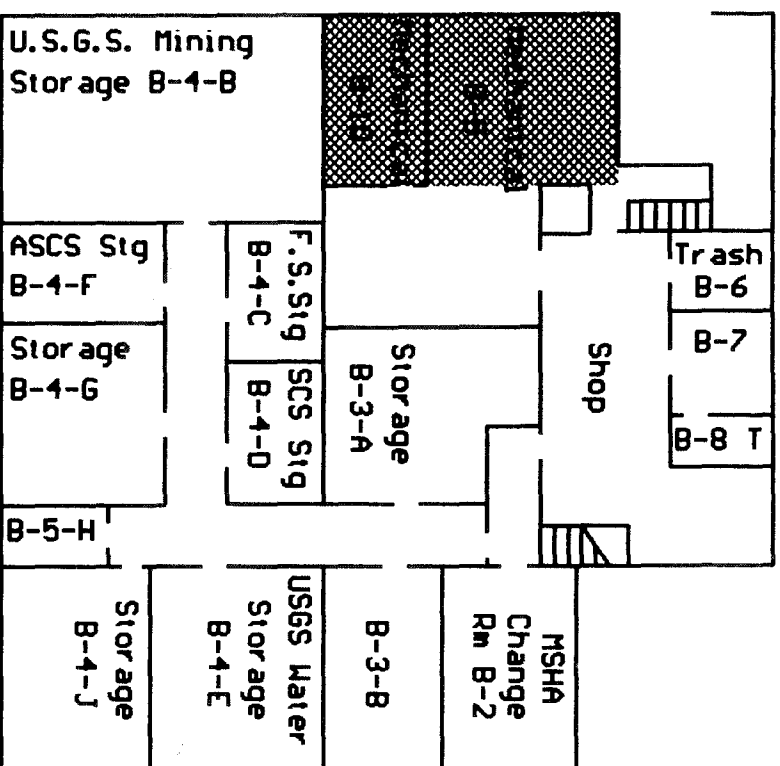
Figure 1.9  
Basement Floor

HVAC Refrigerant Line Fittings  
ACM Homogeneous Area

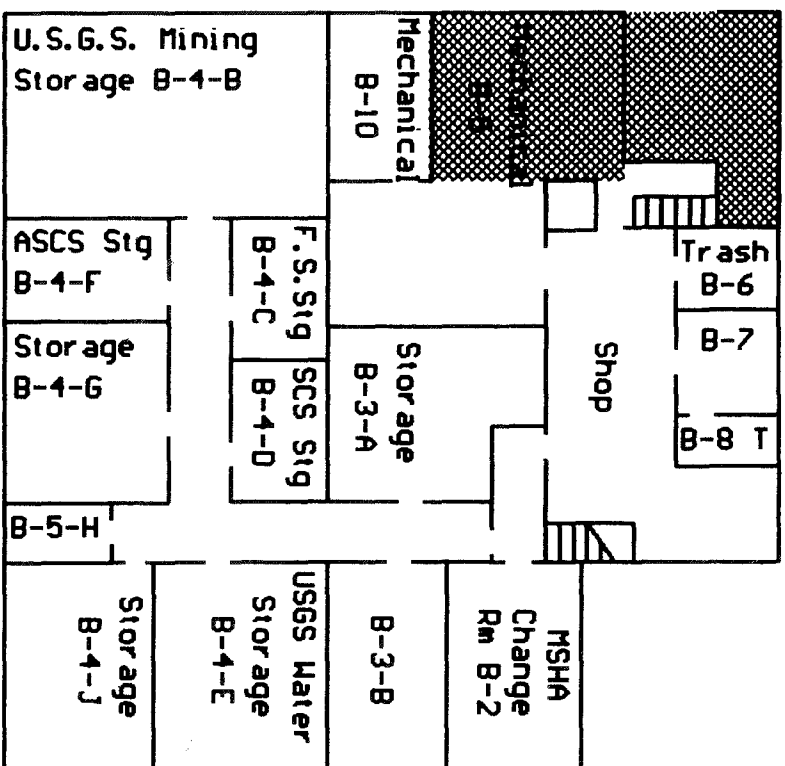
Figure 1.11  
Basement Floor

HVAC Duct Wrap  
ACM Homogeneous Area

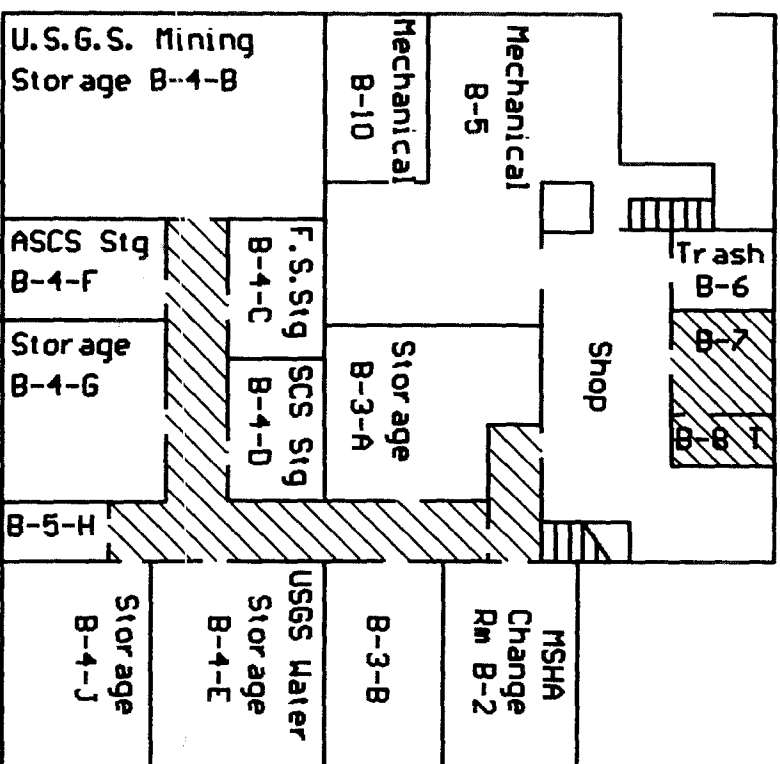
Figure 1.14  
Basement Floor

Floor Tile 9x9 Brown  
ACM Homogeneous Area

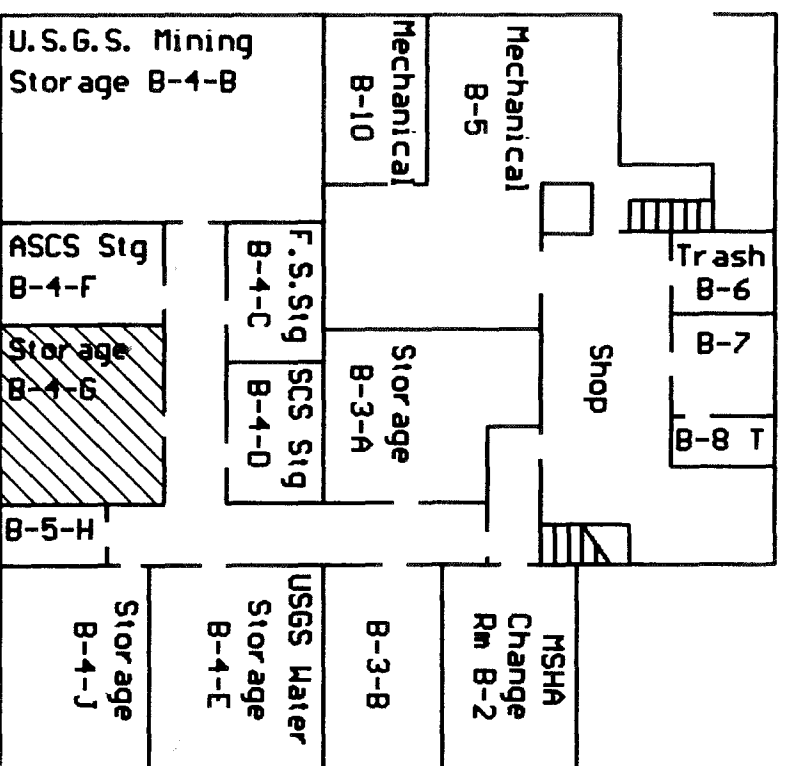
Figure 1.15  
Basement Floor

Floor Tile 9x9 Light Blue (stored in boxes)  
ACM Homogeneous Area  
Floor Tile 9x9 Light Blue  
(stored in boxes)

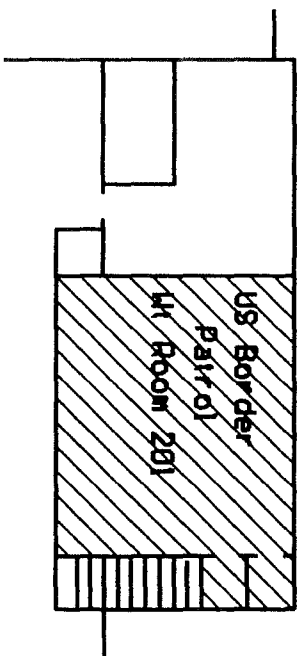
Figure 1.18  
Second Floor

Floor Tile 9x9 White  
ACM Homogeneous Area  
Floor Tile 9x9 White

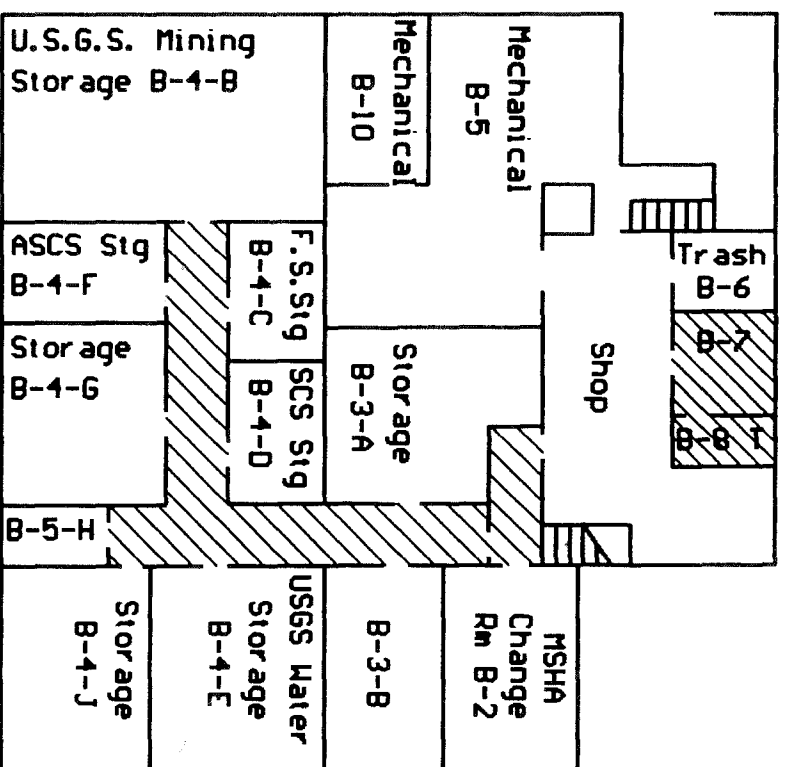
Figure 1.19  
Basement Floor

9x9 Floor Tile Mastic  
ACM Homogeneous Area

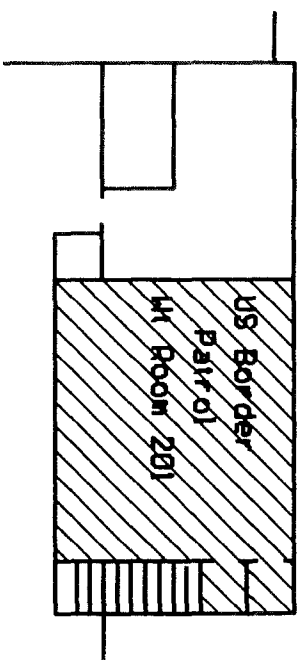
Figure 1.21  
Second Floor

9x9 Floor Tile Mastic  
ACM Homogeneous Area  
9x9 Floor Tile Mastic
